## Historical Cases of Tailings Dam Failures in Peru: An Analysis of The Triggering Factors

### Abstract

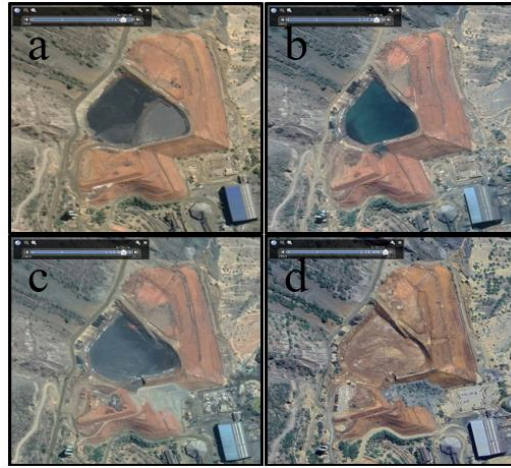
**Figure 1.** Plan images of the North Area tailings deposit condition on four (04) different dates, close to the failure.

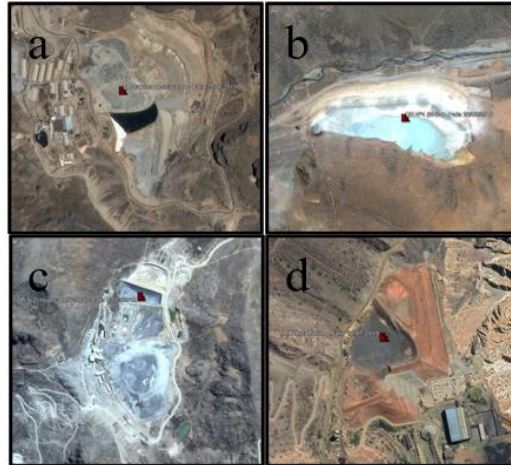
**Figure 2.** Plan images of four (04) tailings deposits with failure events.

Note. [a] Cancha A tailings deposit with failure date of 06/25/2010. [b] Tailings deposit No. 4 with failure date of 03/26/2016. [c] Tailings deposit No. 2 with failure date of 03/03/2018. [d] North Area tailings deposit with failure date of 07/10/2019. Fountain. GEP.

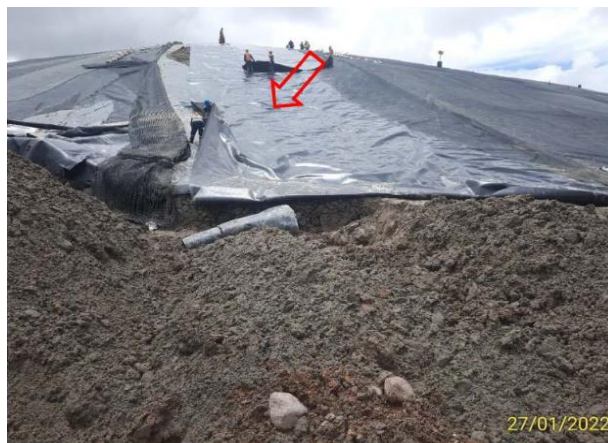
On January 24, 2022, at 5:00 p.m., the spill of coarse and fine tailings from the Huaybillo tailings deposit occurred, as a result of the slide of the main dam and part of the basin, in a volume estimated by the owner of 1,106.26 m<sup>3</sup>. in an area of 2,714.41 m<sup>2</sup>. The Huaybillo tailings deposit is in the Paratía district, Lampa province, Puno region; In UTM projection and WGS 84 datum its coordinates are E: 328366, N: 8291595, zone 19 South. Figure 3 shows the condition of the dam 3 days after failure.

**Figure 3.** Gap covered with geomembrane after carrying out temporary repair on the main slope - northern area of the Huaybillo tailings deposit.

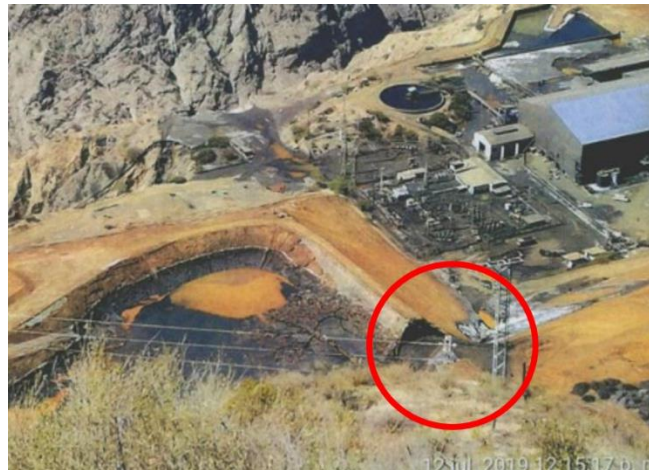
On July 10, 2019, a spill of water and tailings from the North Area tailings deposit occurred, because of the failure of its lateral dam. The water and tailings were channeled towards the electrical substation of the processing plant, damming in an old maintenance workshop, breaking the 1.0 m high safety berm into two sectors and finally reaching the downstream slope of the stream until reaching the Mantaro River. The North Area tailings deposit is in the San Pedro de Coris district, Churcampa province, Huancavelica region; In UTM projection and WGS 84 datum its coordinates are E: 567903, N: 8608358, zone 18 South. Figure 4 shows the condition of the dam 02 days after the failure.

**Figure 4.** View of the breach in the dam 2 days after the failure in the North Area tailings deposit.

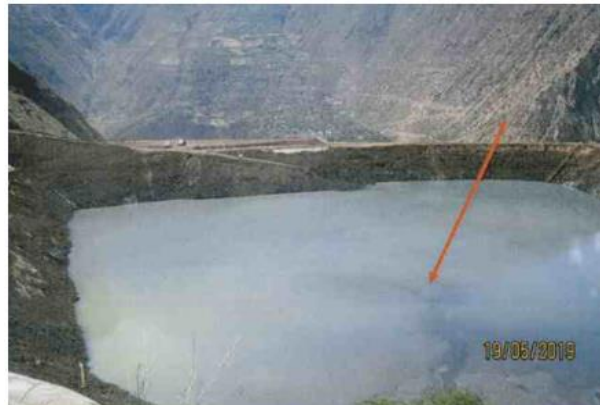
The reflecting pool occupied an area of 33,500.00 m<sup>2</sup>, which represents 79.85% of the total area of the basin of the North Area tailings deposit, which would have had an impact on the stability of the deposit.

The design did not consider the need to move the water body further away from the dam. Likewise, in the last physical stability study, the contact of the slope upstream of the dam with the water body was not considered.

**Figure 5.** View of the water mirror in contact with the dam in the North Area tailings deposit.

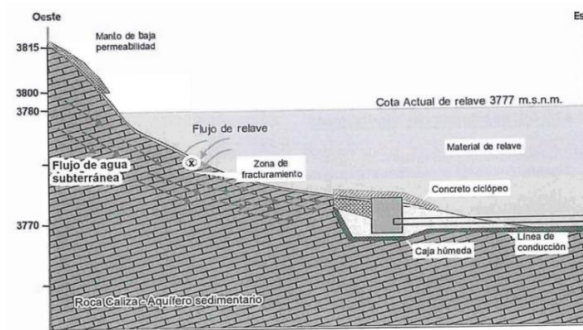
The elevation of the TSF reservoir to a level of 3,778.0 meters above sea level, caused the tailings with water to connect with the water table (vertical flow) through a fracture; and then with the Las Tomas Remnant Water Diversion System, which is buried and, on its way, passes under the TSF tailings deposit, which led to the occurrence of the incident. More details of the possible conditions that caused the spill in Figure 6.

**Figure 6.** Descriptive profile of the possible conditions that caused the TSF tailings deposit spill.

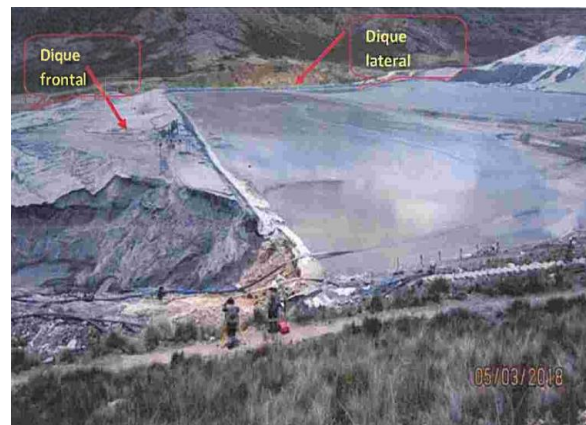
Tailings deposit No. 2 is made up of two (02) dams called lateral and frontal with lengths of 301.30 m and 264.90 m respectively, which are joined in an L shape. See Figure 7. The lateral dam was built with quarry material, and the front dam, called overlift with thick cyclone tailings, was built in two (02) phases with two types of materials. In phase I, the frontal dam was built with loan material formed by compaction and was called the start dam, which was built up to the level of 4,508.77 meters above sea level; and phase II was built with compacted coarse tailings material for the build-up of the starting dam, also called raising with cyclone coarse tailings, for which they used the downstream build-up system. The slope upstream of the lateral and frontal dam was waterproofed with 1.5 mm thick HDPE geomembrane.

**Figure 7.** View of the front and side dams of tailings deposit No. 2 joined in an L shape after failure.

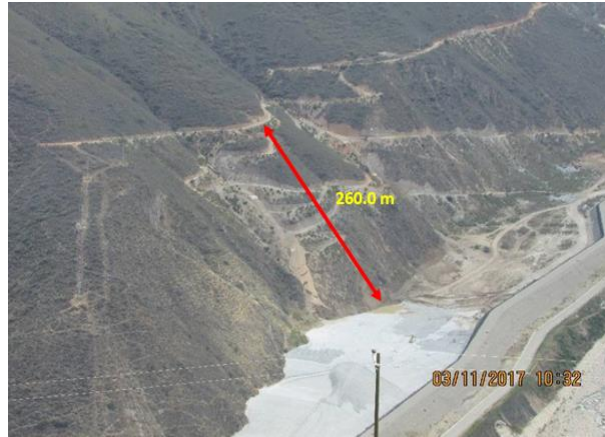
Having exceeded the number of fines in the filtered tailings that make up the embankments arranged in the tailings deposit, with respect to the standard established in the operations manual, facilitating the erosion and circulation of the fine tailings.

The fine tailings that circulated with the water from the rainfall covered the drainage screen built on the slope upstream of the containment dam, not allowing drainage through this medium.

**Figure 8.** View of the distance between the crown channel and the Yuracyacu filtered tailings deposit, with drainage of uncontrolled runoff water in said section.

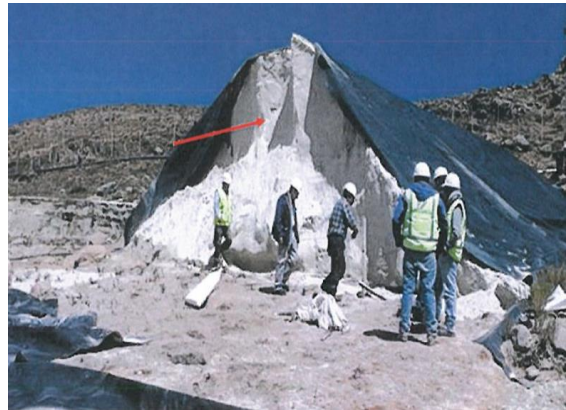
On March 26, 2016, at 06:30 a.m., the tailings stored in tailings deposit No. 4 were discharged, because of the movement of the containment dam downstream, corresponding to the section: progressive 0+013.80 - progressive 0+030.60. The saturated tailings from the basin and dam reached the Collpamayo River and sectors adjacent to tailings deposit No. 4. The opening of the tailings dam and the cavity of the basin were left with almost vertical slopes, due to the presence of silt and the consolidation process of the tailings. See Figure 9. Tailings deposit No. 4 is in the district of Chachas, province of Castilla, Arequipa region; In UTM projection and WGS 84 datum its coordinates are E: 810945, N: 8301593, zone 18 South.

**Figure 9.** View of the breach of the tailings deposit No. 4 dam, with an almost vertical slope.

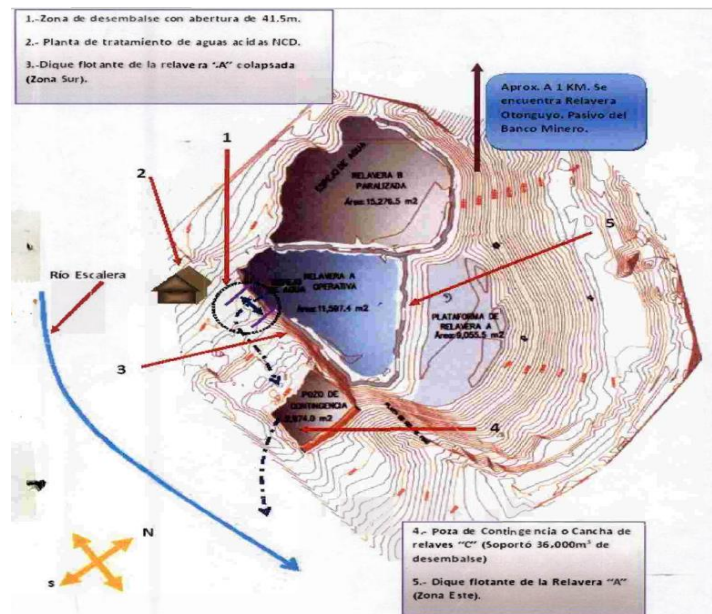
On June 25, 2010, at 6:00 p.m., a water leak suddenly occurred along the slope of the southern side of tailings deposit A, approximately 1.00 m below the crown of the dam. This fact caused the erosion and slide of the slope, causing a gap with an opening of 41.50 m and the spillage of the tailings into the basin of the new tailings deposit C, being filled. See Figure 10. The overflow discharged into the bed of the Escalera River, running along the cause in a stretch of approximately 3.50 km. The impacted area consists of terraces located on both banks of the river. Tailings deposit A is in the Huachocolpa district, Huancavelica province, Huancavelica region; In UTM projection and WGS 84 datum its coordinates are E: 501255, N: 8556021, zone 18 South.

Figure 10. Sketch with the location of the relevant areas of the failure event.
