## Historical Cases of Tailings Dam Failures in Peru: An Analysis of The Triggering Factors

### Abstract

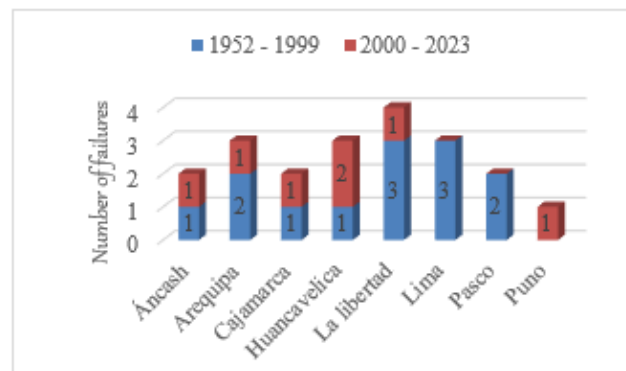
Figure 11 shows the distribution of incidents on a regional scale. A change in the distribution pattern is observable when the data set was divided into two periods: 1952 to 1999 and 2000 to the present. Incidents of failures in Arequipa, La Libertad, Lima and Pasco decreased drastically during the last period. For example, the distribution of incidents in the Lima tailings dams was 3 cases before 2000, while after 2000 there were no incidents. Similar trends were seen in Pasco.

Figure 11. Regional distribution of tailings dam failures in Peru.

Although the distribution of incidents was lower after 2000 for the Arequipa, La Libertad, Lima and Pasco mines, for some regions, the number of incidents remained the same or increased. For example, the distribution of incidents in the Huancavelica tailings dams was 1 case before 2000, while after 2000 there were 2 incidents.

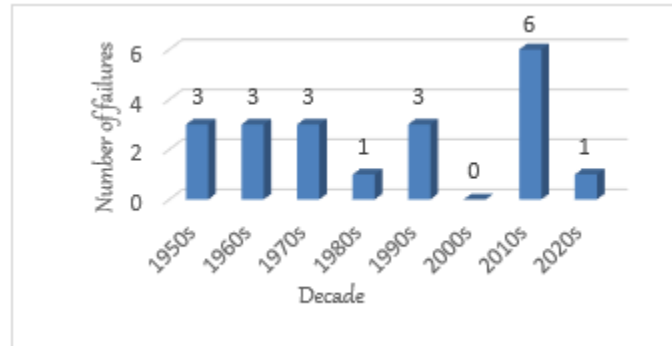
Figure 12 shows the temporal distribution of the incidents. The first incident reported in the database was from a mine in Lima in 1952; the mine produced Cu, Ag, Pb, Zn. The number of failures in tailings dams remained low until the 1990s, which could be related to the absence of an exclusive oversight body for the specialty of geotechnics that recorded and archived the information on all cases of failure and not only of serious cases. Then, during the 2000s, no incidents were recorded, which could be related to administrative issues due to the transfer of mining supervision powers from the Ministry of Energy and Mines to OSINERGMIN.

Figure 12. Temporal distribution of tailings dam failures in Peru.

In contrast, the number of failures increased significantly in the 2010s, which could be related to the global demand for metals and the transfer of environmental powers from OSINERGMIN to OEFA, thus having other organizations to record this type of events. . According to the database, from 1952 to 1999 a total of 13 incidents occurred, representing 65% of the total number of cases and from 2000 to the present a total of 7 incidents occurred, representing 35% of the total number of cases. According to the updated database, the tailings dam failure rate was  $\approx 0.28$  per year.

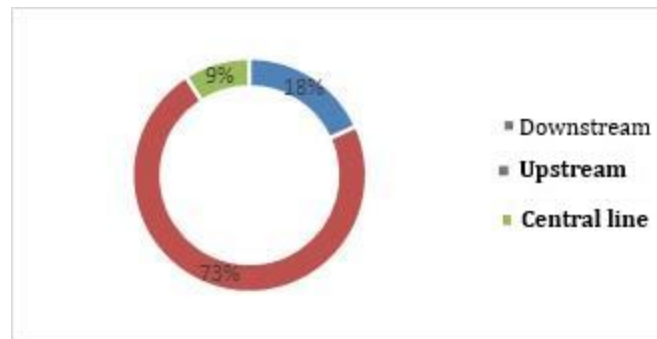
Figure 13 represents the relationships between regrowth methods and the number of failures. Tailings dam surge methods are generally divided into the following types: Upstream, Downstream and Centerline. The majority of incidents occurred in dams with upstream surge ( $\approx 73\%$ ,  $n=8$ ), the upstream surge type was the most economical option, however, it had the greatest possibility of failing in times of extreme weather or natural disasters. In contrast, the number of incidents of Downstream and Centerline surge dams were significantly lower with ( $\approx 18\%$ ,  $n=2$ ) and ( $\approx 9\%$ ,  $n=1$ ), respectively.

Figure 13. Failures of tailings dams according to their type of surge.

The case of the Yuracyacu filtered tailings deposit was omitted from this graph because its dam is classified as Homogeneous. Likewise, 8 cases of failure that occurred before the year 2000 were omitted due to the lack of information on the characteristics of their dams.

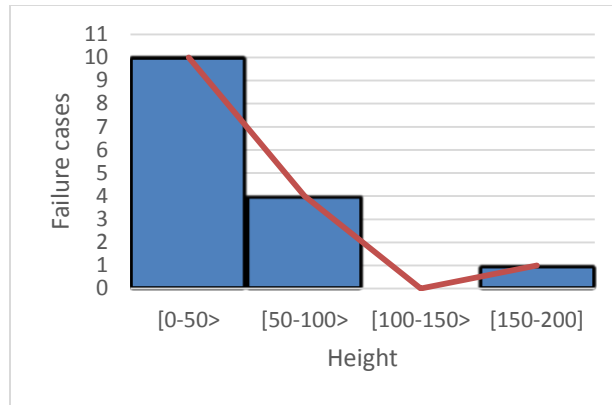
In Figure 14 most of the incidents occurred in dams with heights less than 50m (50%,  $n=10$ ), with heights between 50m and 100m (20%,  $n=4$ ), no incident occurred in dams with height between 100m and 150m, and in dams with heights greater than 150m (5%,  $n=1$ ). It should be noted that data on the height of 5 tailings dams with failure before the year 2000 was not obtained.

**Figure 14. Frequency distribution according to height of the tailings dam**

Regarding the previous paragraph, it is emphasized that increasing the height of tailings dams does not prevent failures, on the contrary, static liquefaction can be caused by an increase in pore pressure due to an excessive lifting rate of the dam. in short periods of time or other processes that alter the state of tension of the prey. However, the trend shown in the graph may be due to greater controls in the design, construction and operation of higher dams by mining owners.

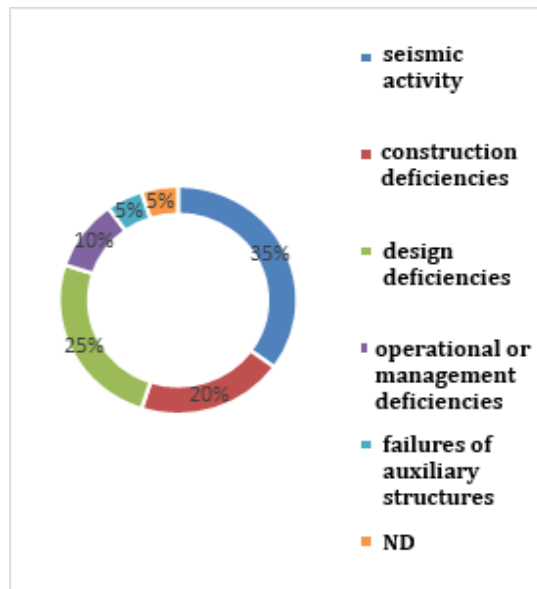
**Figure 15. Tailings dam failures according to the main cause of failure**

Seismic activities and design deficiencies were the two main causes of tailings dam failures, with (35%, n =7) and (25%, n =5) cases, respectively. Likewise, (20%, n=4) of the cases were generated by construction deficiencies, (10%, n=2) due to operational or management deficiencies, (5%, n=1) due to failure of auxiliary structures and the last (5%, n=1) the causes are not known.

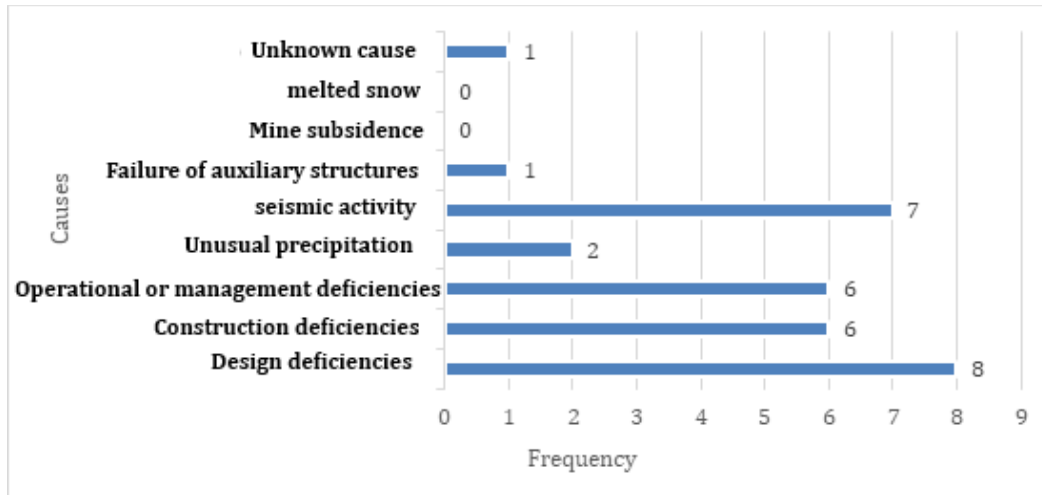
It is well known that several problems must converge for a failure to be triggered. Therefore, Figure 16 shows the frequency of all the causes related to each of the incidents in the tailings dams. For this analysis, design deficiencies, seismic activities, operational deficiencies and construction deficiencies were the four main causes of failures in tailings dams, with frequencies of n=8, n=7, n=6 and n=6 cases, respectively.

Figure 16. Frequency of all causes related to each of the incidents

On the other hand, unusual precipitation and failure of auxiliary structures were the least frequent causes, with  $n=2$  and  $n=1$  cases, respectively. Finally, in none of the failure cases were mine subsidence or melted snow observed as possible causes.

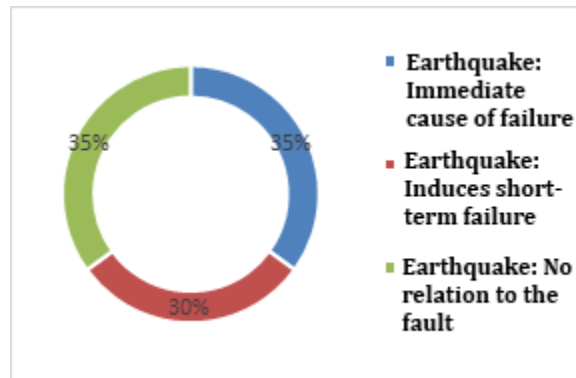
Figure 17 shows the percentage distribution of incidents in tailings dams based on their relationship with recorded earthquakes.

Figure 17. Relationship between failure cases and recorded seismic activity

The relationship of the recorded earthquakes with the cases of failure of tailings dams was divided into the following types: Immediate cause of the failure, Induces the failure in the short term and Has no relationship with the failure. Most incidents are related to seismic activity (65%,  $n=13$ ). In contrast, only (35%,  $n=7$ ) of the failure cases are not related to seismic activity.
